On the slope protection measures - Japanese Experiences -

Osamu Kusakabe¹

¹ International Press-in Association, Tokyo 108-0075, Japan

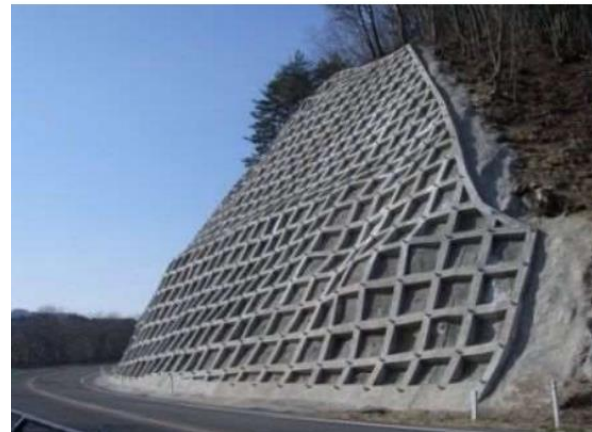
Fig. 1 Typical slope protection work
